## Another Macro Repair Job

By Fritz Schulze

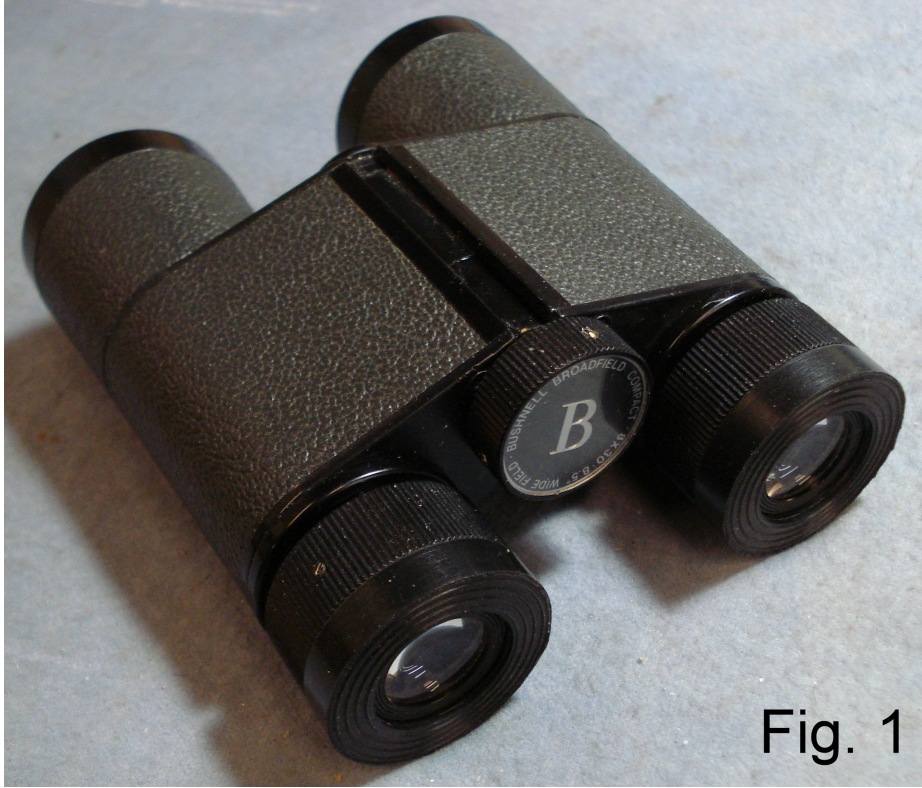
Fig. 1

It was in response to an advertisement in a local newspaper that I decided in 1973 to buy a Bushnell 8x30 Broadfield Compact binocular for \$ 115, at a time when Japanese prism binoculars were offered for \$ 25. The all metal binocular is no lightweight: it weighs in at 526g and feels heavy and solid (Fig.1). It features central internal focusing, roof edge prisms, and coated optics (Fig. 2). I figured that at that price I could expect adequate quality. Indeed, the instrument did not disappoint me, it performed most satisfactorily **until** in 1996 our 6 year old grandson with his inquisitive fingers dropped it! Following Murphy's Law it fell so to do the most damage: on an eyepiece, cracking the internal focusing mechanism.

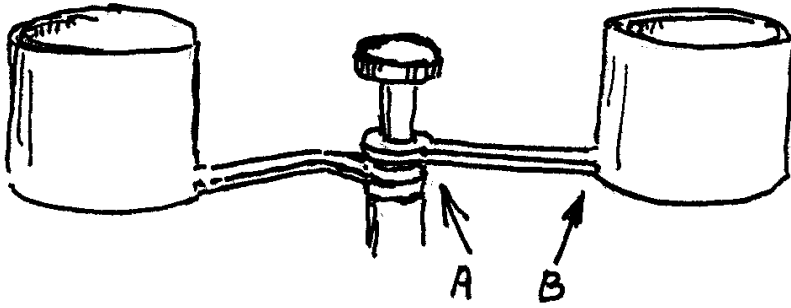
Fig. 3 Weak = rupture points

This particular binocular has an internal scissor-like mechanism that moves the eyepieces simultaneously in and out controlled by a central knob (Fig. 3). From the central focusing spindle two symmetric levers, Bushnell calls them "bridges", reach out and carry the eyepiece sleeves which, in turn, slide in the body tubes. This means that the lateral friction in the tubes exerts considerable forces on these levers which have two weak points A and B at each end (Fig.1). And that is exactly where one of them broke.

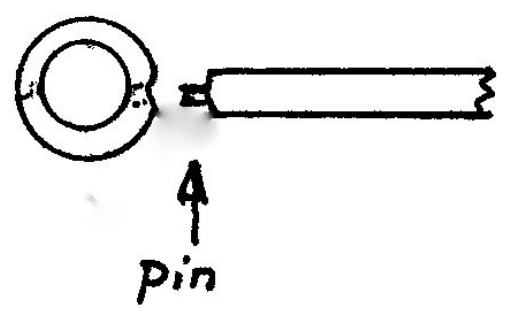
Fig. 5

First repair (notice reinforcing pin)

My motto has always been *Waste not, want not* and don't throw anything out that can be fixed, particularly not an otherwise fine pair of binoculars. My first attempt to repair the damage was a twofold one: at one end of the broken lever I inserted a small pin for strength and cemented the fracture with epoxy (Fig.5). At the other end I reattached the eyepiece sleeve with two angle brackets screwed on (Fig.10). This repair had one drawback: the thickness of the epoxy, about 0.3mm, which I did not allow for, displaced the respective eyepiece sleeve outward, causing some friction in the tight fitting bodytube. Still, the repair held until about half a year ago when it finally gave in.

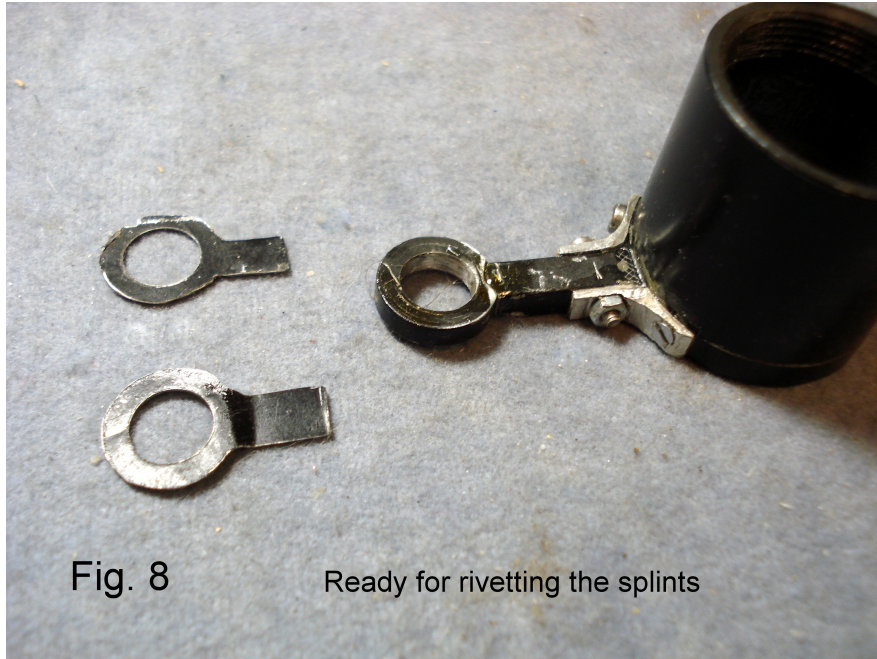
Fig. 8

Ready for rivetting the splints

To make the splints I clamped two pieces of aluminum doubled between pieces of hardwood, drilled first a 4mm hole, then the final 8mm one (Fig.9). Then, slipping the pieces back on the drill bit shaft and superimposing the broken bearing, I scribed the outline on the black aluminum sheet as well as the shape of the arms. With the help of a strong pair of scissors (don't laugh, a sturdy pair inherited from my mother!) I cut the required shape and finished it up with needle files and light sanding (Fig.8).

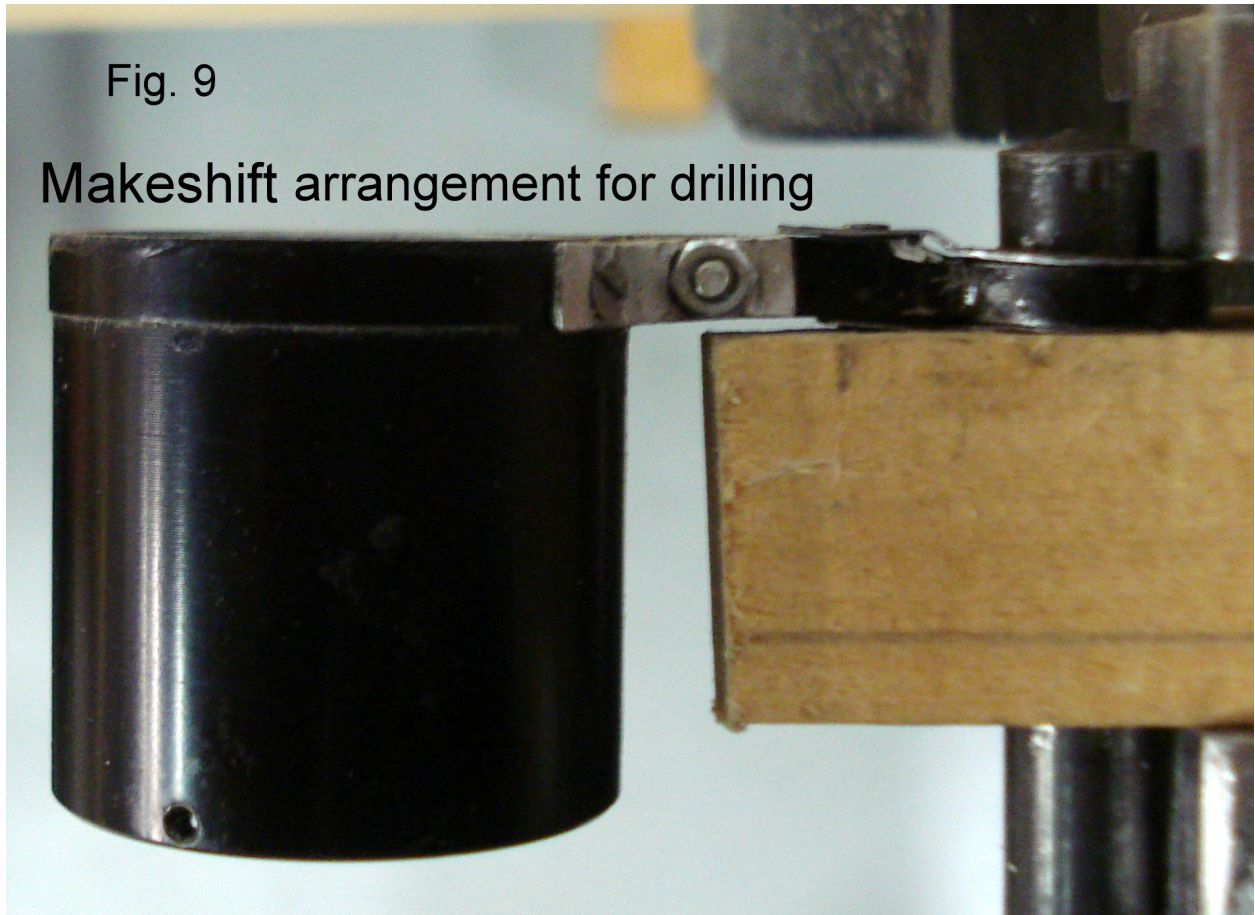
Fig. 9

Makeshift arrangement for drilling

Meanwhile I had recemented the broken joint again. It was now strong enough for the subsequent handling. I threaded all again on the 8mm drill bit shaft and arranged some sort of clamping the assembly for the drilling of the hole for the rivet which I had machined from an aluminum nail (Fig.9). I had discarded the idea of using a screw, the thickness of the head and nut would have limited the sparse room available for the focusing movement. I drilled the hole for the 1.5mm dia. rivet, counter sunk it and hammered the rivet in. So far so good (Fig.11).

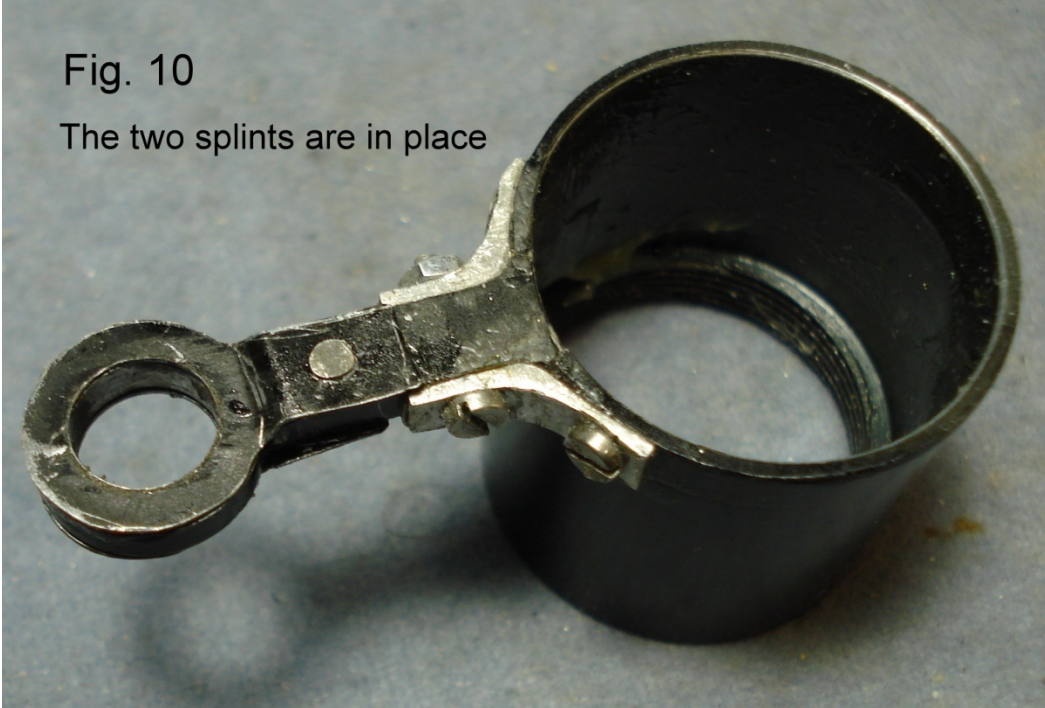
Fig. 11

Details of final repair
