## Another Macro Repair Job

By Fritz Schulze

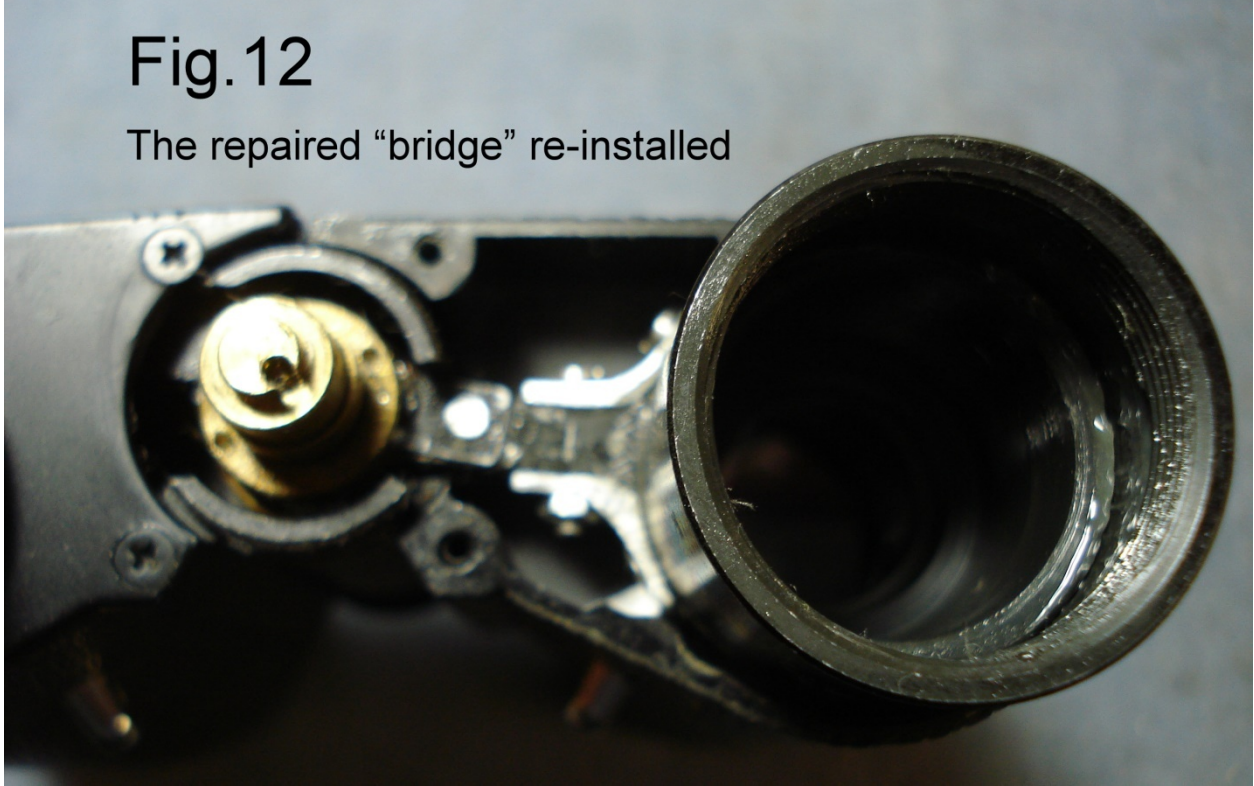
## Fig.12

The repaired "bridge" re-installed

Final assembly proved the success of the ambitious repair effort. Everything worked fine (Fig.12). The optics was reinstalled, the diopter scale adjusted, the focus checked, and a great sigh of relief breathed. My binocular is now, hopefully, again good for another twenty years (but I won't be around to verify that!).
